**TECHNICAL ASSISTANCE TO
HAKUPU COCONUT OIL ENTERPRISES**

NIUE

January 2001

Prepared for: South Pacific Biodiversity Conservation Program
Apia, Samoa

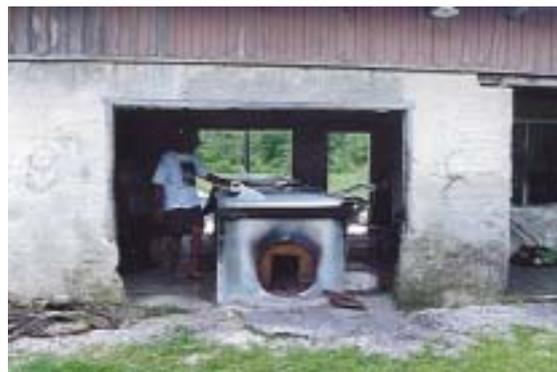
2. The DME drier as built

The Samoan builder lacked a number of the materials specified in the *Trainer's Manual* for the construction of the drier. He was innovative in trying to overcome the problems. Thus, instead of using mesh (unavailable) to support the *umu* stones used for thermal storage, he used galvanised iron sheet loaded with sand. Unfortunately, this actually insulated the drying surface and allowed the heat from the furnace to escape too fast. The innovation would probably have worked had the builder punched rows of holes along the ridges of the corrugated iron sheeting. In addition, the furnace drums were placed in a position that did not allow air to flow around the drum as intended. Furthermore, the chimney, again due to the lack of materials, was too short and of only 100 mm diameter rather than 150 mm specified in the *Manual*. Given the circumstances at the time of construction, this was the best that could be done. However, the combined effect was an inefficient drier which smoked excessively even when using the most readily available fuel – the coconut shells and husks.

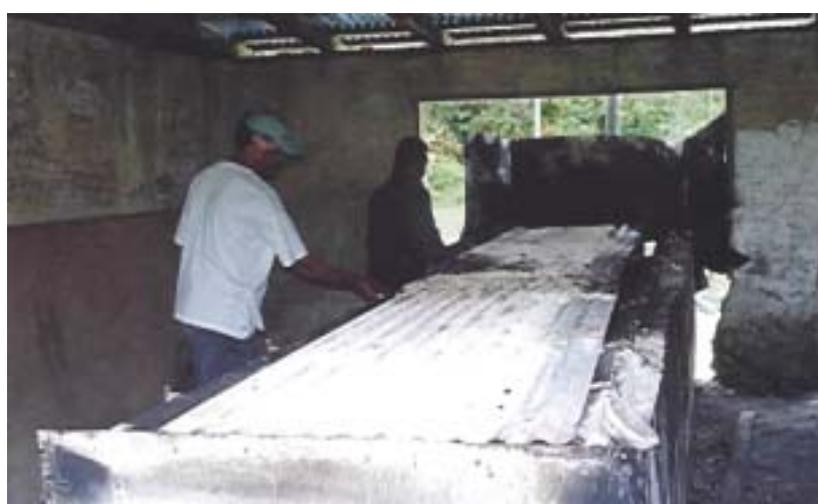
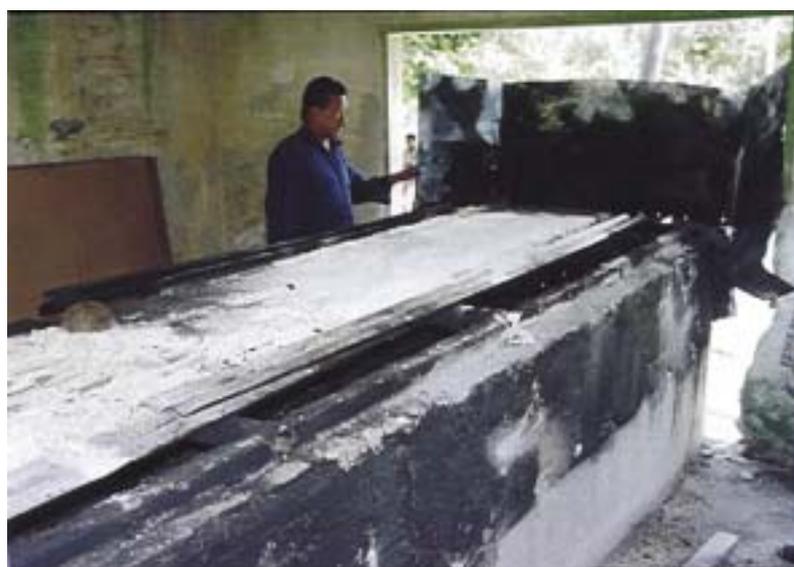
3. above and 4. below. The DME drier opened up to show the use of corrugated iron and sand to provide the heat bank. The corrugated iron was used because of the unavailability of mesh to hold the *umu* stones specified in the **Training Manual**

Having located a source of reinforcing mesh on Wednesday, I worked with the local community to strip the drier back to the walls, removing the corrugated iron sheets and the severely scorched wooden ‘beams’ on top of the concrete walls. On Thursday, concrete beams were built on top of the walls so that there would be no internal wood. Extra pipe cross-beams were also put in place. The furnace drums were repositioned and the mesh ordered. Both Friday and Saturday were community “half-days” for shopping and for garden work. [Also, on both days Logo was unavailable because of a significant “hair-cutting” ceremony in his home village of Liku.] Sunday is not a working day. However, I had useful discussions at a lunch arranged for two new Deacons inducted into the Hakupu church.

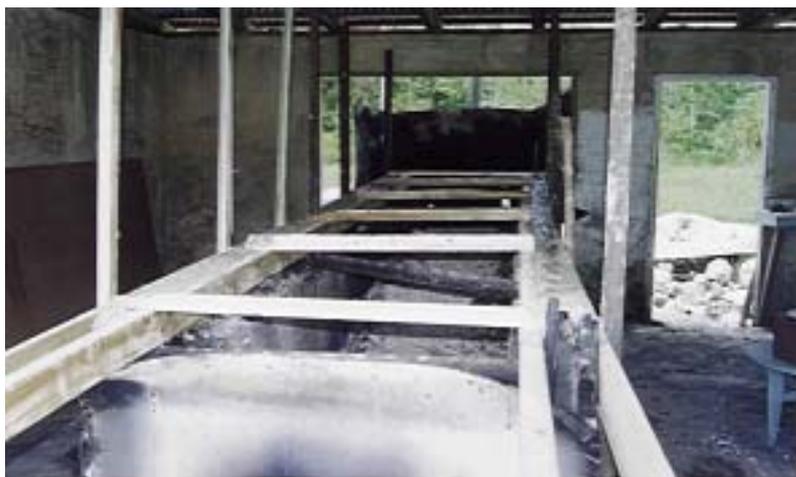
5. Form work for construction of concrete beams on drier walls to replace burnt wooden beams

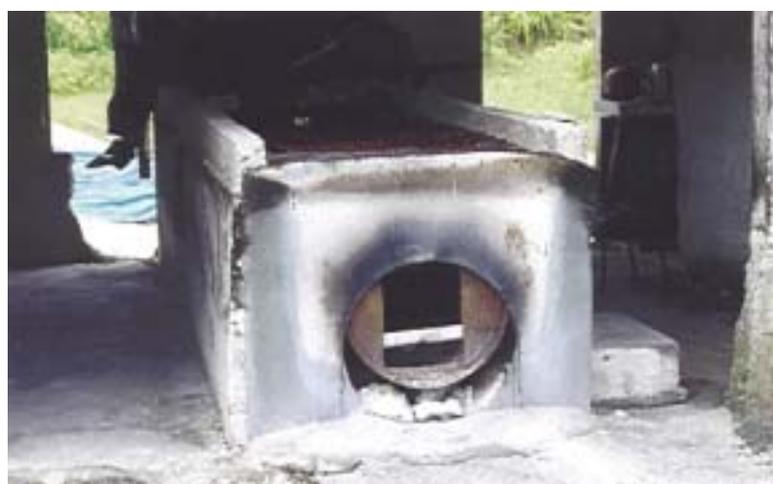
6. Shows the completed concrete beams with mesh between them to hold the *umu* stones. The furnace has also been raised.

On Saturday, the form work was removed and two layers of mesh positioned and a full layer of *umu* stones were collected and put in place. The original galvanised flat iron sheeting was repaired, put back in place, re-riveted together and scrubbed down on Monday. On Tuesday, external wooden battens were used to seal the sides, the chimney was extended by a further 1.5 m, a grate placed in the furnace and a new temporary door was fitted to run horizontally across the face of the furnace. The lack of concrete nails prevented us from completing the external wooden battens completely but Logo understands what needs to be done and has the skills to finish the task.

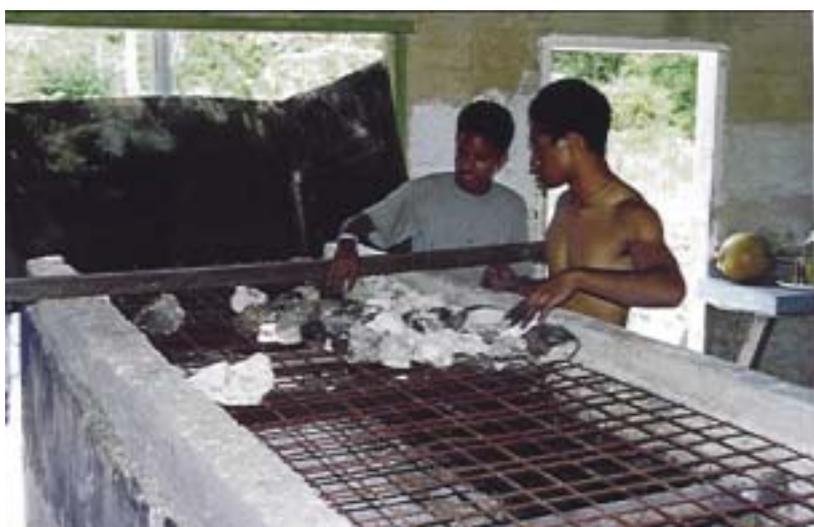
7. Loading the stones on the mesh to provide the heat bank

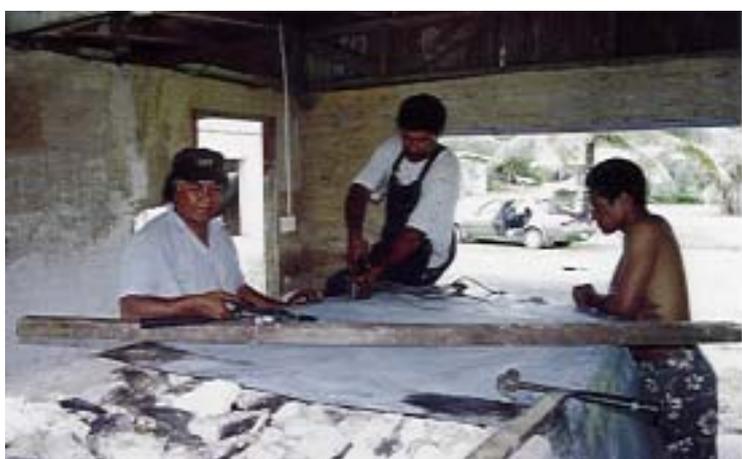
9. Clendon, Logo & Nigel rebuilding drier top

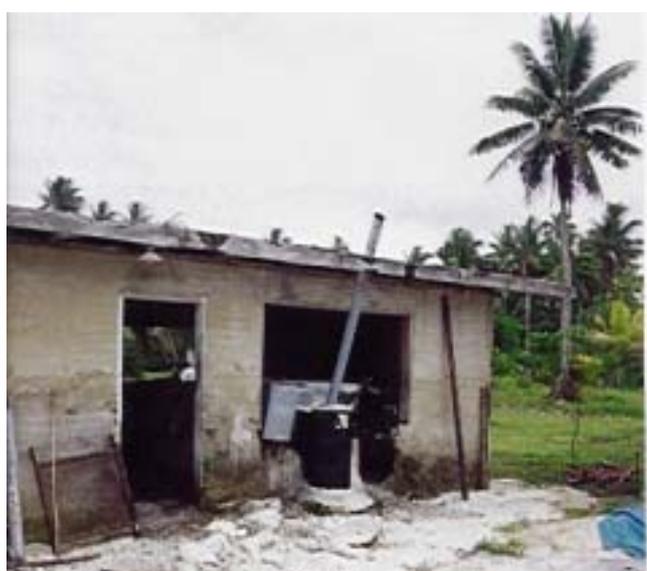
10. Drier chimney (too thin & too short)

- The performance of the drier should be monitored to see if it is necessary to increase the diameter of the flue to further improve the combustion in the furnace.

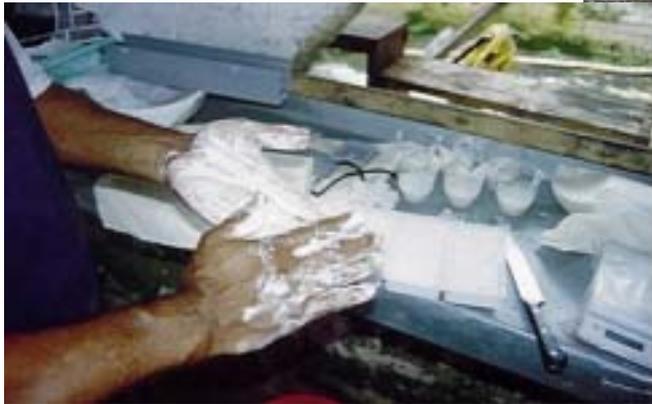
11. Soap making equipment given to the Project

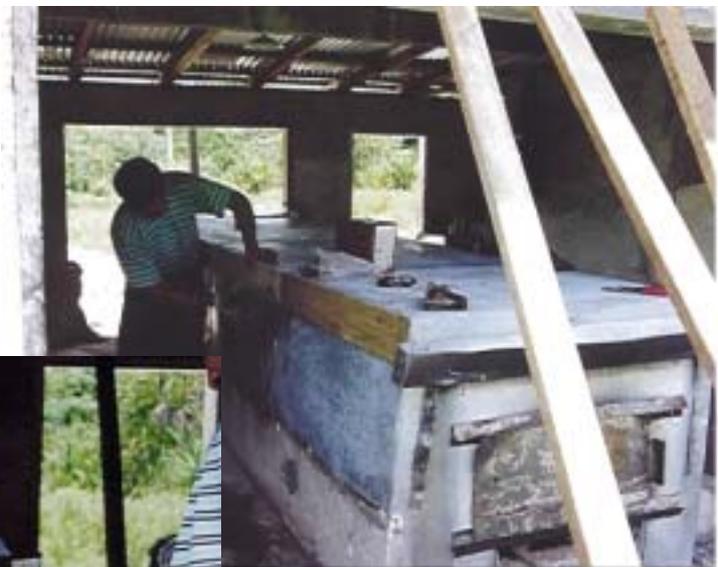
13. Drier side battens being fixed in place. Note the door to the furnace. This slides horizontally.

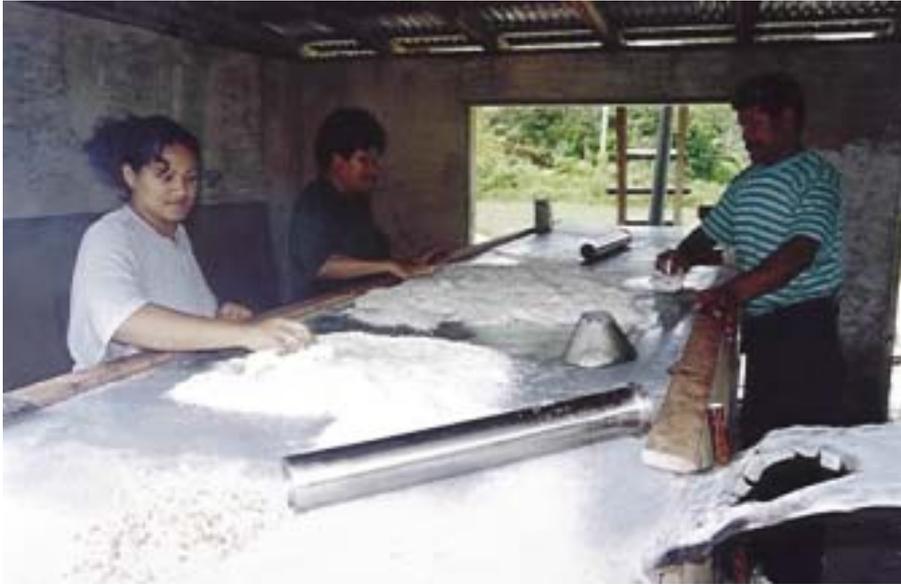
15. Girl, Masani and Logo testing the drier. (Note candlenut in front LH corner followed by 2 batches of coconut)

It was nearly mid-day on Tuesday before we were able to light the furnace. The flue drew much better and there was very little smoke coming out the sides. The drier now appeared to work as originally intended. However, much greater attention will have to be paid to managing the furnace since the fire burns much more efficiently with the new grate and
